**Image Quality Deterioration
Check for Charge Unit Contamination**

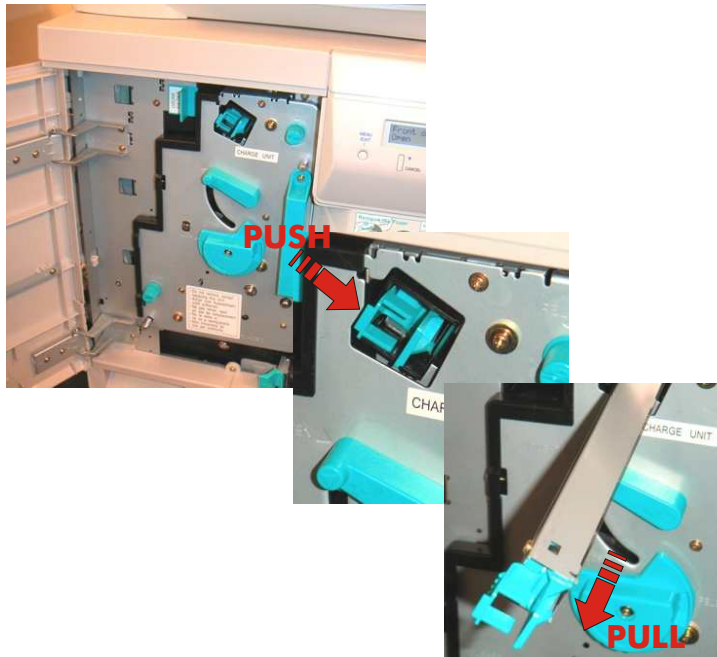
1. Open Front Door and remove Charge Unit.

2. Check Unit for Contamination/Black Burn Marks. In case of heavy Contamination try to clean with Toothbrush/Compressed Air or replace Charge Unit.
